AREA DIESEL SERVICE NEWSLETTER Q4-2020

Turbocharger Misapplication

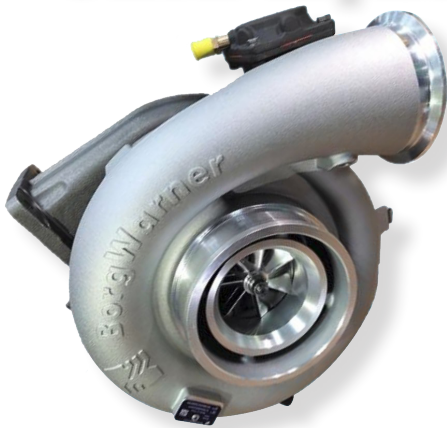
GTA45 Replacement Turbo for Series 60 Applications

BorgWarner and Area Diesel Service are pleased to announce the release of the GTA45 turbocharger* for Detroit Series 60 EGR engines. This value-driven model features a Forged Milled Compressor Wheel (FMW) for increased turbo life and durability.
